TOP FORM

The best selling crossover from the Bologna company tackles the hardest reliability test: **50,000 km in only eight months**, between March and November 2019.

A pierced radiator and an attempted theft could not stop it

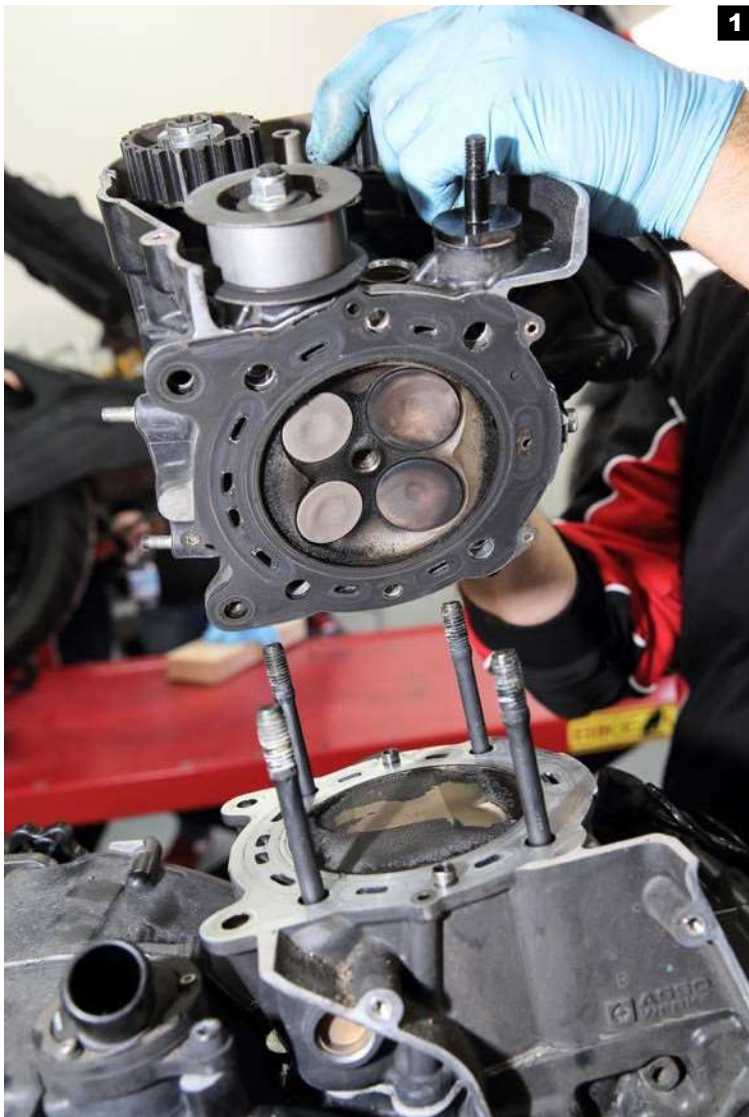
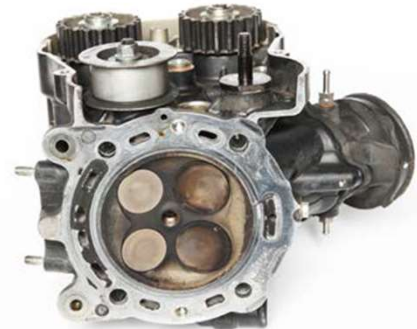
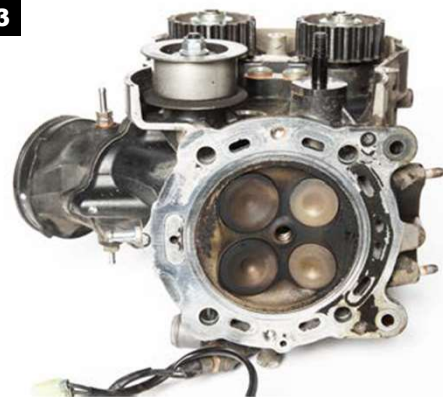
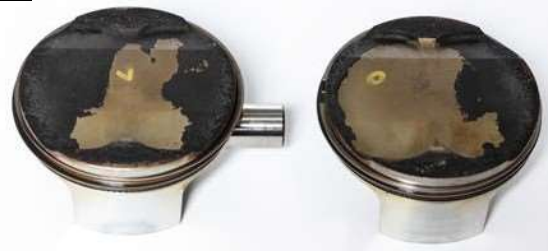
1, 2, 3 and 4. Here's how cylinder heads and pistons looked like. Truly minimal traces of fuel combustion, especially in the vertical cylinder. The reduced traces of carbon residues stems from the relentless research focused on combustion chambers and piston ring profiles, including tolerances between the piston and the cylinder as well as the valve guide material. All this was confirmed also by a **virtually non-existent lubricant consumption, which was never topped up between one service and the other.**

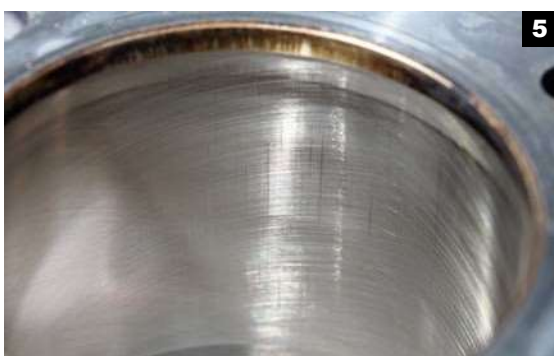
5

5. This is the inside of the vertical cylinder, which only features a few minor scratches that did not affect the performance. Indeed, this engine gave its best in terms of power and maximum torque right after 50,000 km. 6. The conditions of the valves showing traces of unburnt fuel were also within normal ranges.

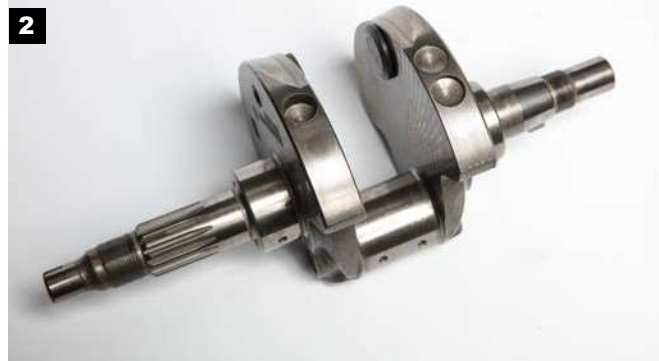
1 and 2. Design and real-life picture of the Testastretta connecting rod assy. And the machined areas on the crank webs to balance it. In this case, there is nothing to report, other than the fact that these parts are absolutely in top form. **3 and 4.** The plain bearings ("shells") of the connecting rods and crankshaft were in tip top shape given the miles it ran.

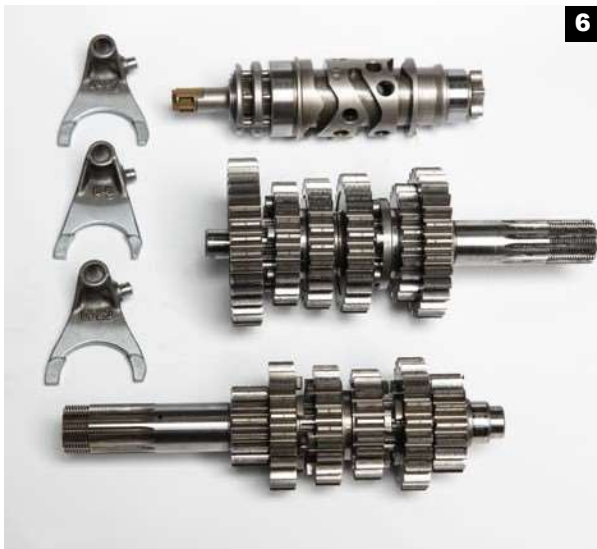
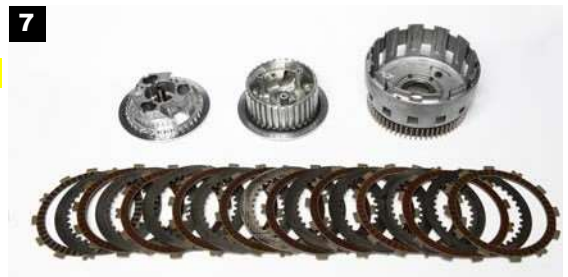
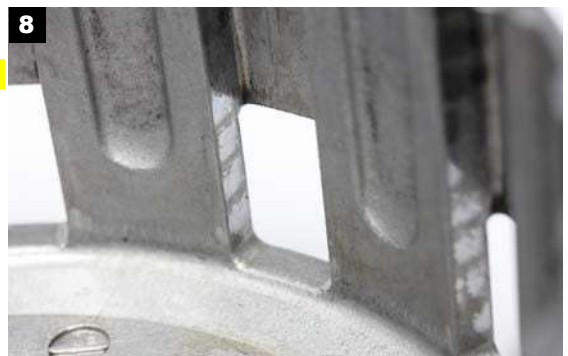
6. The gearbox assembly was in mint condition both in terms of the gears and the minimal selector fork wear.

7 and 8. The clutch was in good shape with minimum plate wear, while the housing and inner hub were in perfect condition: this is the first time, with all the engines we analysed after our Long Tests, that we do not find any traces of wear or even grooves that prevent the clutch plates from sliding properly.

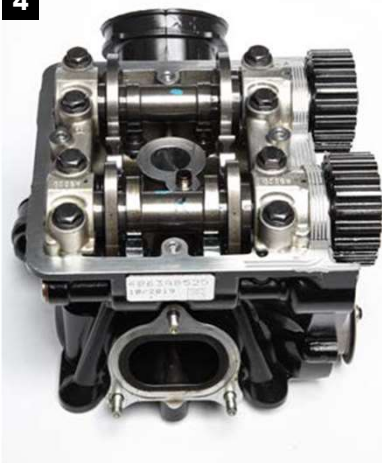
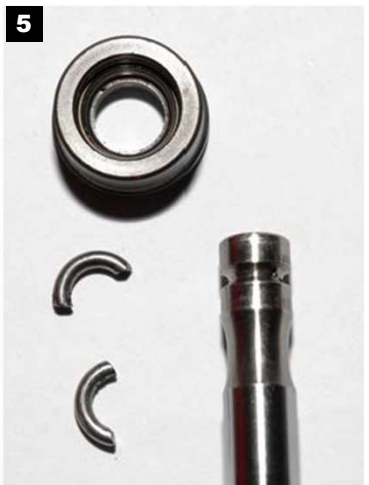
4 and 5. The rational use of space with the camshafts visibly displayed. At the scheduled check

all the operating plays were clockwork. These two tiny steel split rings lock the valves in place.

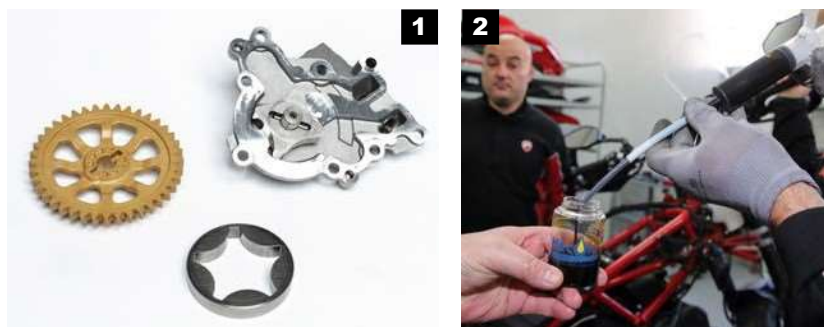
Very few red marks were seen in the lubricant sampled at every service and analysed by Mecoil lab in Florence. During the first part of the trip the metal (iron and aluminium) content was close to the limit, which is compatible with the running-in period. During following tests the oil showed halved levels of metals and fell back into normal ranges.

1. The trochoid pump (found in top conditions) and its plastic gear driven by the crankshaft. 2. Lubricant sampling for Mecoil lab. We have not reached the minimum amount of oil during our 50,000 km. In all the other Long Tests, with the exception of the one with Yamaha Tracer 900, we had to top up the lubricant periodically. Below is a summary sheet of lubricant sample results. The decrease in viscosity is compatible with the high mileage endured between oil changes.

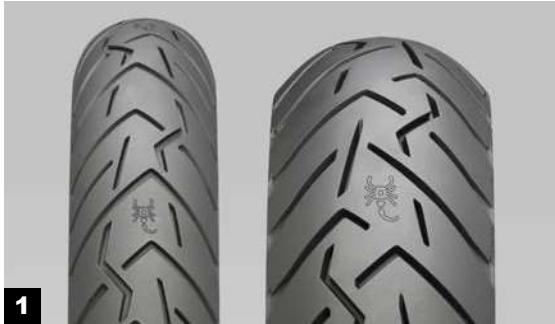
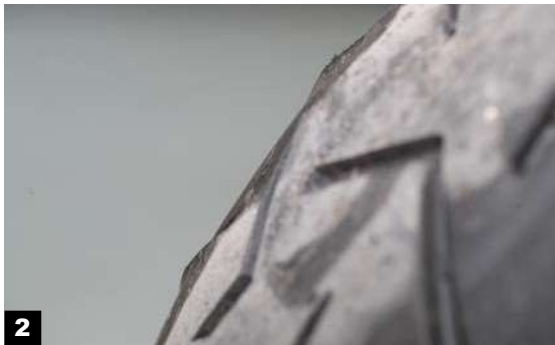
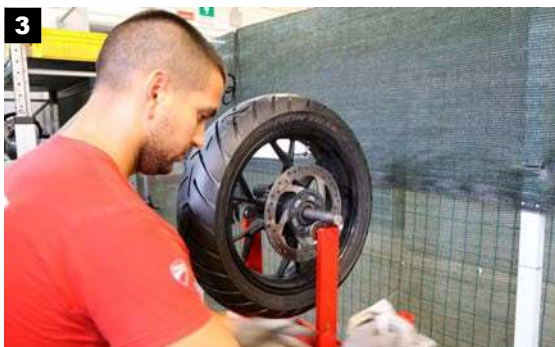
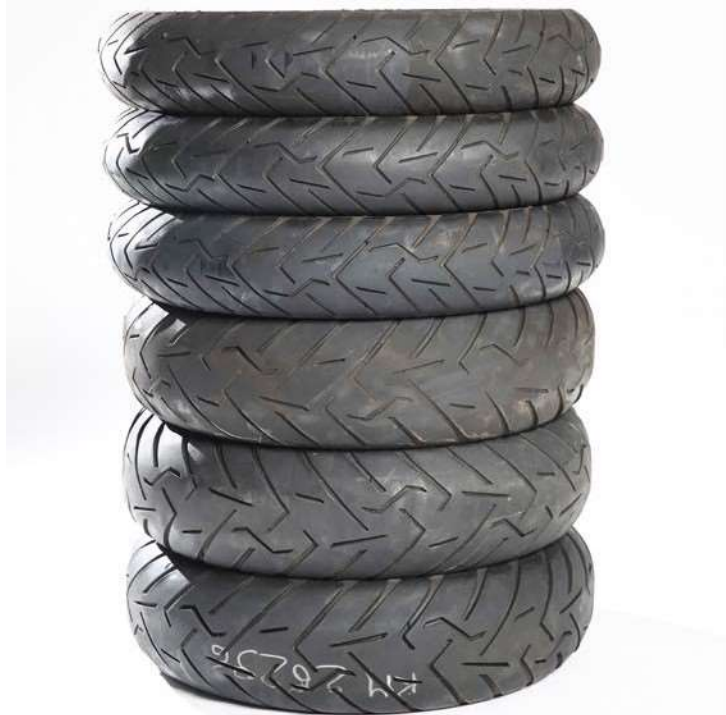
Above, 3 tyre sets changed at 15,000, 26,000 and 41,000 km. The fourth was still on the motorbike; with this set we drove the remaining 9,000 km left to reach our 50,000 km goal.

1 and 2. The profile of Scorpion Trail II, new and after 15,000 km: as you see, they have a tendency to wear off on the outer side, though we never had any problems in terms of grip or stability, even at this high mileage.

3. Tyre assembly was performed directly by Ducati Service. As a Ducati part, the price of a set is 357 Euro, which includes the cost of fitting them onto the rims.

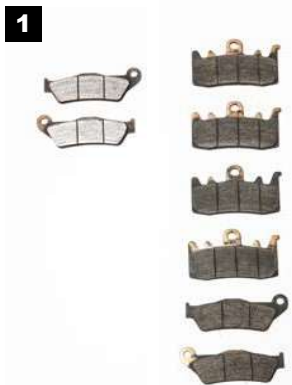
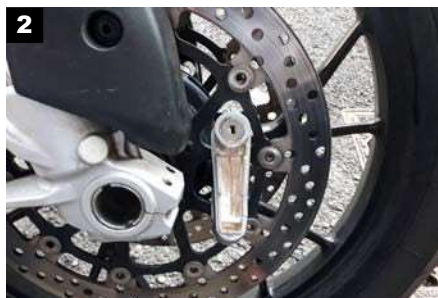
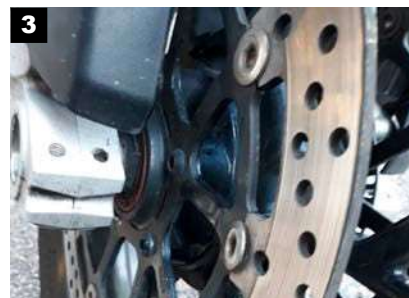
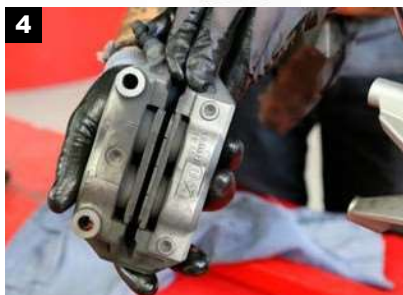
The set of rear brake pads was a bit “soft”, a “theft-proof” disc and two pistons that pushed too much. Nevertheless, the effectiveness of combined braking was always ensured by the very performing Brembo-Bosch combo.

1. We changed the rear brake pads at 20,000 km, way before the front ones, which were replaced at 26,000 km. With the second set of rear brake pads we made it to the end of our 50,000 km trip with almost twice as much friction material. This mileage is absolutely within normal range: in other Long Tests the wear was way higher, as in the case of BMW RT, which lasted only 10,000 km. **2 and 3.** On our Multistrada we had to change the right front disc at 21,500 km because the hub connection flange bent because of an attempted theft. The disc lock did its part and the Multistrada was saved; even though the light alloy flange causing the disc to float did not break, it took quite a hit and was damaged. **4.** A higher wear in the outer brake pad is worth mentioning, as compared with the inner brake pad, in the front right calliper. This had no connection with the attempted theft, because this issue came out since the beginning of the test. Most probably this is due to the pistons on that side of the radial calliper: they do not run immediately back into their housing as the brake lever is released on the handlebar and keep pressing (though slightly so) on the brake pad.

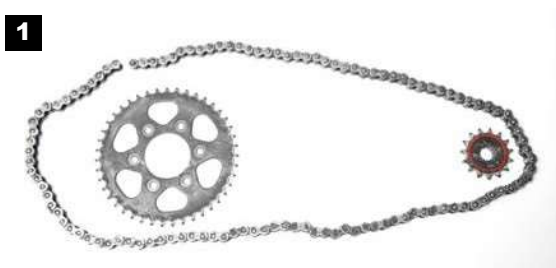
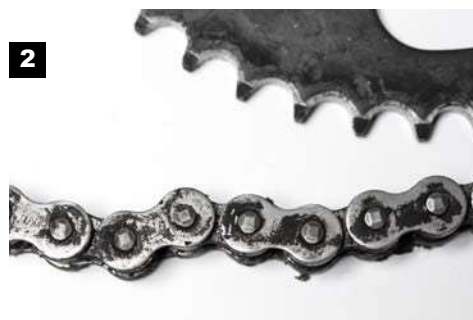
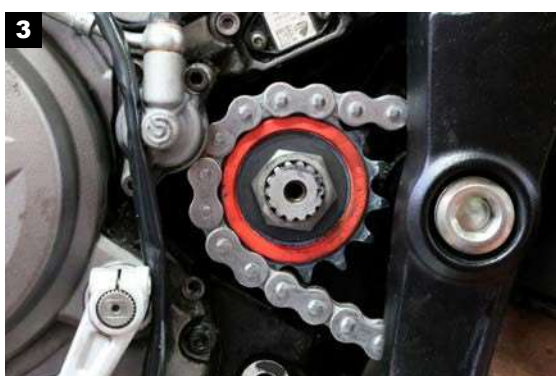
1 and 2. At 26,000 km we replaced the original final drive. It was a precautionary measure given the unknowns of a long journey across Europe. Actually, the time was not right to change the chain (DID 525 HV3), even though two or three links were beginning to show some signs of seizing; as concerns stretch, we were well within the limits. **3.** Front and rear sprocket conditions were good. The second final drive kit, also a Ducati genuine part, made it to the end of the test (24,000 km) and was still “in shape” then. With an instrument we monitored chain efficiency in terms of stretch and we measured a residual “life” close to 80%. As a spare part, the chain, front and rear sprocket set costs 232 Euro.

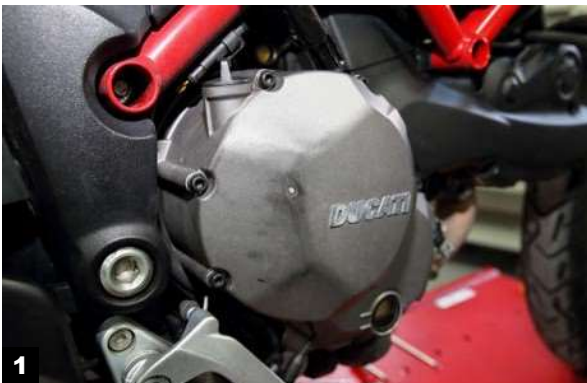
▲ The bolts, the various steel or light alloy components showed no signs of oxidisation. With the exception of the right crankcase, at the clutch cover area, which was worn due to the contact with the boot, the bodywork, engine and frame paint was in top shape

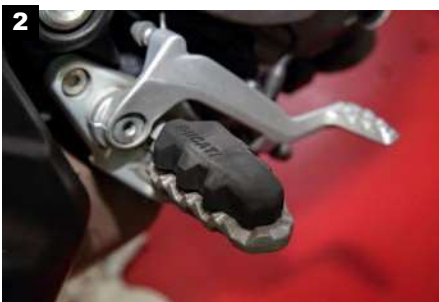
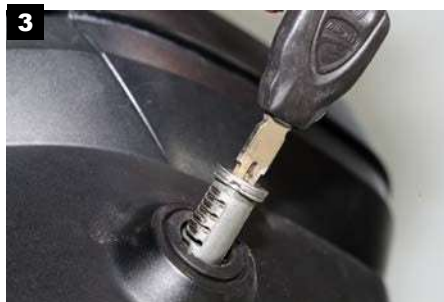
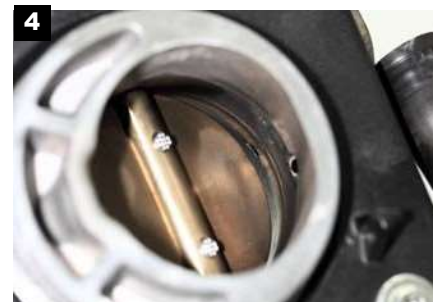
▼ A certain hesitation at idling (only at the end of the test), a lock that comes off and the footpeg rubber covers that came off.

If the Multistrada engine did not fail us as far as use and - as we explained in the previous pages - health conditions go, a few exceptions to the more than satisfactory Long Test of this versatile bike from the Borgo Panigale brand came from the clutch cover paint (1) that came off quite rapidly because of the contact with my right boot, and the footpeg rubber covers (2) which are press-fitted onto the footpegs and come off quite soon: we lost four of those. The side plastic panniers are easy to fit and remove, and absolutely waterproof, though at the end of the test the lock came off (3) from the left pannier.

Towards the end of our test the engine occasionally showed a few hesitations while riding in the city at low rpm: a small carbon residue on the outer circumference of the throttle valves in one of the throttle bodies (4) prevented the valve from closing properly. No issues were recorded any more when opening more the throttle control.

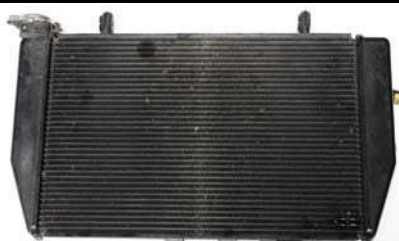
5

5. At 39,483 km the cooling radiator got punctured; an object, probably a rock shot out by the front wheel, opened a hole in one of the tubes where the fluid flows. Fortunately the hole was quite small (with minimum fluid loss), and we were not far from the next scheduled stop. It was subsequently replaced by

Ducati technicians. 6. The "heart shaped" exhaust system is almost hidden to the sight taking up the rear space behind the engine. The front exhaust manifold, the one exposed to the elements, showed surface oxidisation, though less than in other previous Long Tests, specifically those involving Honda Africa Twin, Kawasaki Versys 650 and Yamaha Tracer 900. The silencer coating also withstood the test.
